**SECTION 2B (GEOMORPHOLOGY) Technical Memo from Watershed Sciences
by Laurel Collins and James Chayka, 3/7/07**

SECTION 3C (ACTION PLAN: CULVERTS)

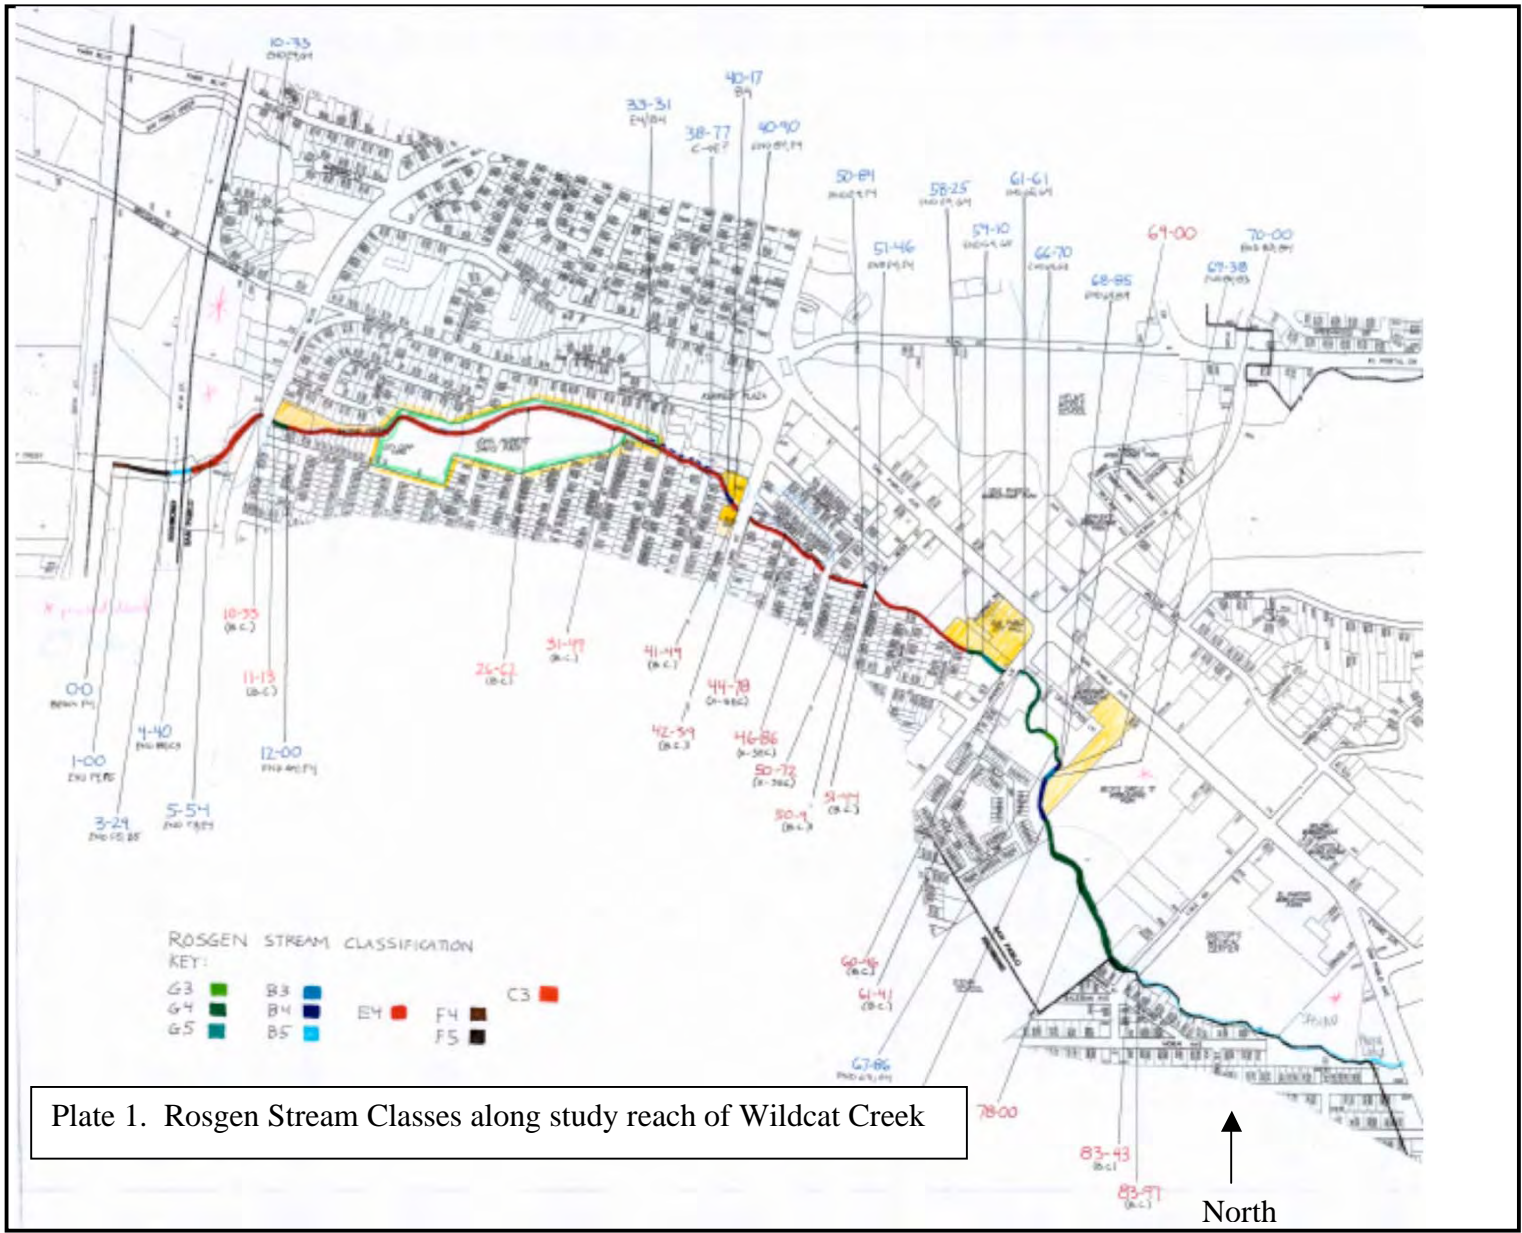
Plate 1. Rosgen Stream Classes along study reach of Wildcat Creek

In general, the study reach changes from an F type channel below the wooden railroad trestle crossing to mostly an E channel to about 300 feet downstream of the Church Lane, where it then changes to a B channel. Between Church Lane and Vale Road the channel

is mostly a G channel, with a small section of B near the middle. The E channel segments are most floodprone, while the G and F channel segments are the most inherently unstable. Bank erosion tends to predominate in F channels and bed incision predominates in G channels.

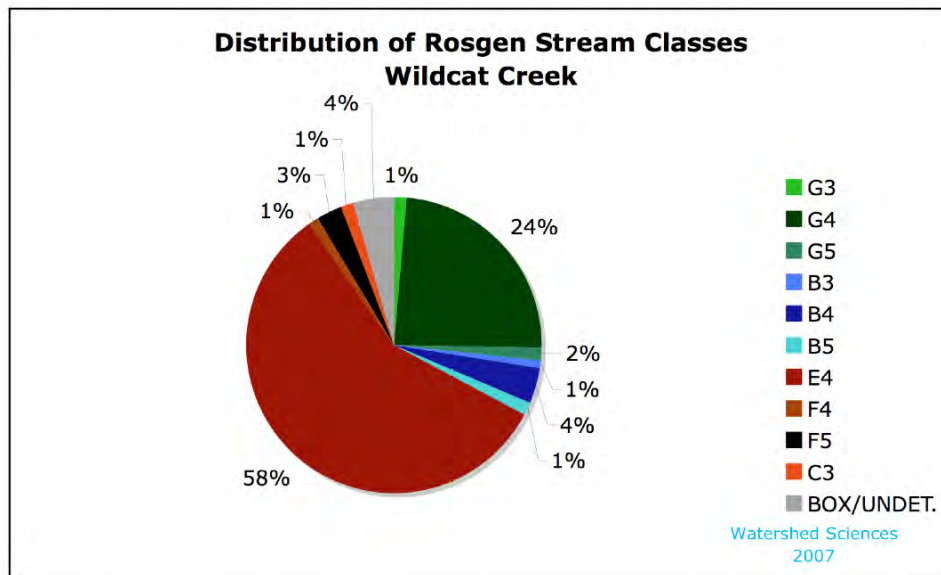
Figure 2. Percent Length of different Rosgen Stream Classes in study reach.

Figure 2 shows the percent length that is represented by each stream class. The E4 channel comprises 58 percent of the study length and G4 is 24 percent. Box culverts and B4 conditions each represent 4 percent, with all other conditions each representing 3 percent or less of the remaining study reach.

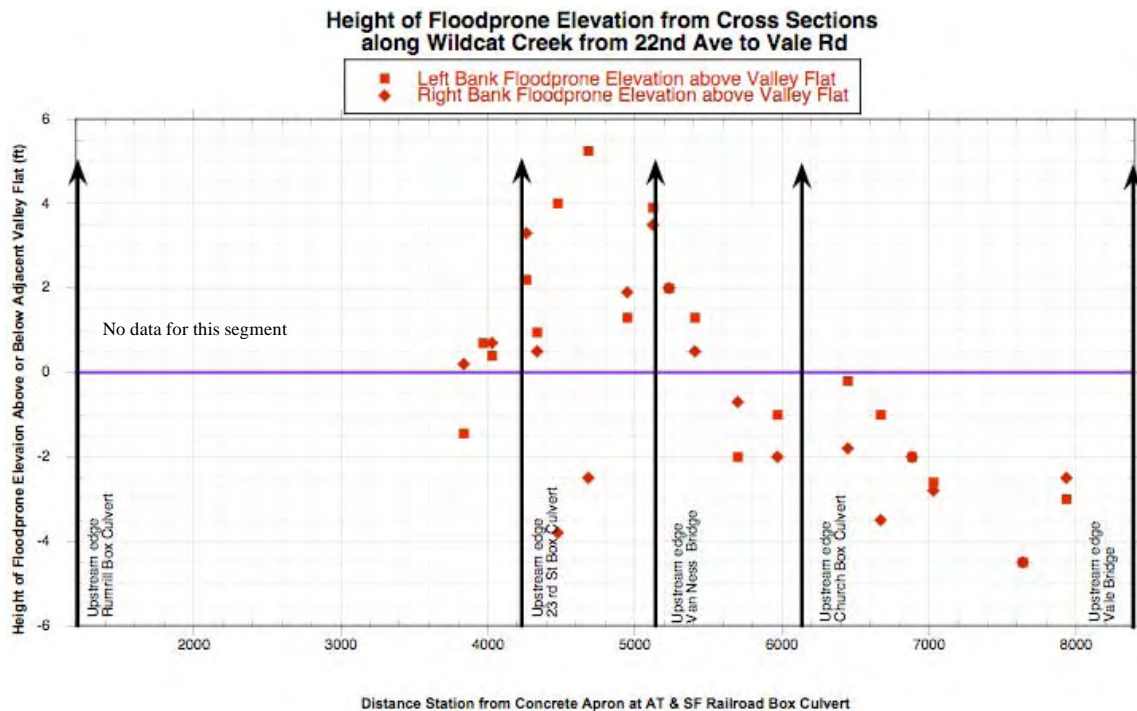
Figure 3. Floodprone elevation relative to valley flat.

Our cross-section data, as well as personal accounts from local residents and county officials, confirm that many reaches within our study area experience flooding. Many cross-sections revealed a tendency to flood both banks, while those that do not flood, or are unable to flood, are likely to have an entrenched morphology. Figure 3 below illustrates the floodprone elevations determined at discrete cross sections. No data was collected downstream of distance station 3800 feet. The graph does not indicate the lateral extent of potential flooding. The data indicates that the segment between 23rd Street and Van Ness Avenue is most floodprone and has sections where the valley flat is 4 feet below the floodprone elevation. University Ave, which is along the north side of Wildcat Creek, corresponds to this segment, and is an area well known for flood problems.
